Inspection Perfection LLC
1010 University Ave. PMB #1865
San Diego, CA. 92103

Re Inspection at: 123 Main St
San Diego, CA. 92101

Confidential Inspection Report

Summary Report - Significant Findings

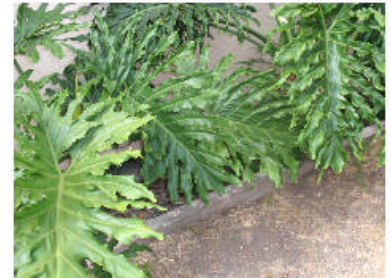
Raised flower boxes attached to building retain water that will have constant contact with foundation & exterior wall creating possible water intrusion. Flower boxes should be installed with separation from dwelling. Recommend further evaluation by a general contractor.

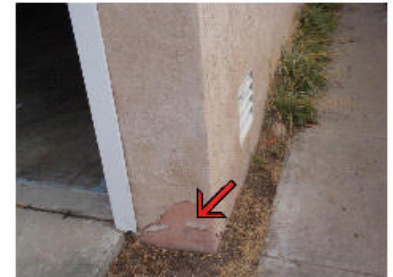
Stucco requires weep screed, separation 4 inch clearance from earth or 2 inch clearance from a concrete walkway to allow proper exterior draining. No screed present. Time of construction may predate this requirement. Area may be vulnerable to moisture damage wicking from the ground. Recommend to evaluate further prior to close of escrow.

Stucco contact with ground shows deterioration. Some of the finish coat of stucco has deteriorated. Recommend further evaluation by a licensed general contractor prior to removal of contingencies.

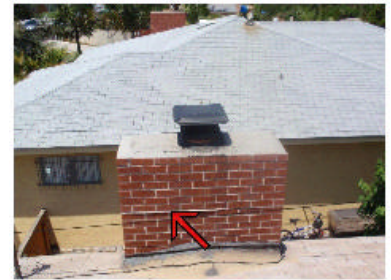
Attention Needed - The exterior stack needs some attention. Some portions of the grout has deteriorated. Recommend further evaluation prior to removal of contingencies.

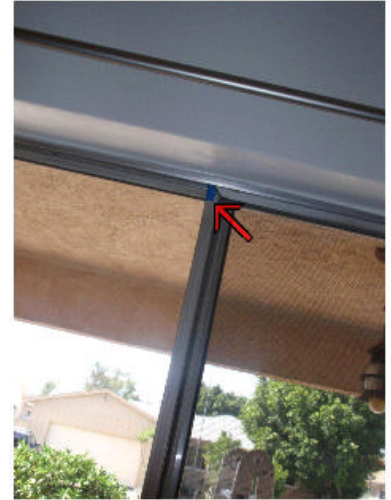
Aluminum horizontal sliders, Screen is installed,
Action Necessary - At least one window or associated hardware needs repair or replacement.
Framing is loose.

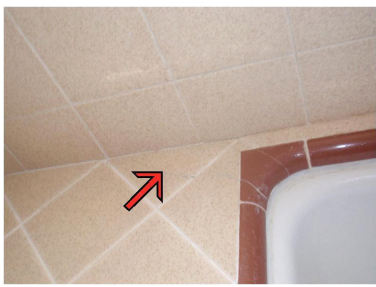
Hairline crack

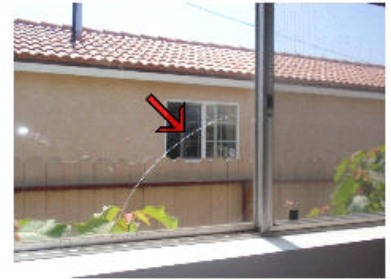
Aluminum single pane, horizontal slider, Screen is installed, Tested, Latch doesn't secure or needs repair. Recommend correction. Action Necessary - At least one window or associated hardware needs repair or replacement. There is at least one broken window pane.

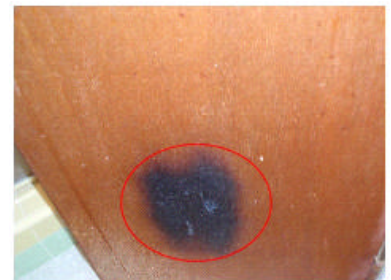
Type - wood, hollow, Attention Needed - The entry door or hardware to this bathroom needs some adjustment or repair to function appropriately. The door skin is damaged from wall heater. It is no longer performing as intended.

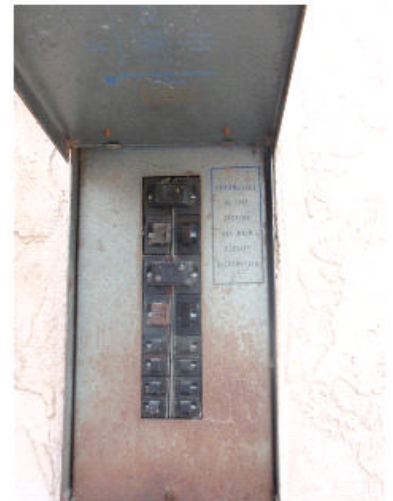
Brand - Pushmatic, Size, Could not determine capacity. Bulldog Pushmatic panels/breakers are 30 - 50 years old and dated technology. Operation of breakers are thermal mechanical and are prone to fail over time. Replacement of breakers are hard to find and expensive. Recommend further evaluation by a licensed electrician.

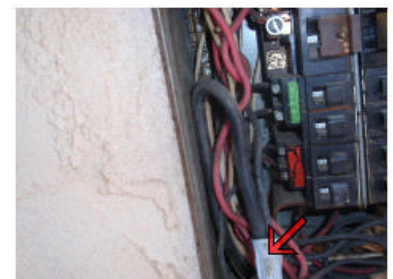
Action Necessary - The breakers/fuses in the main power panel are inappropriately matched with wire gauges that are too light for the breaker/fuse allowed draw. An overdraw condition could cause melting, insulation overheating, or fire. IMMEDIATE ACTION IS REQUIRED. Recommend further evaluation by a licensed electrical contractor prior to removal of contingencies.

Electrical stoves require 30 or 40 amps of service. Could not locate services at panel. Recommend further evaluation by a licensed electrical contractor prior to removal of contingencies.

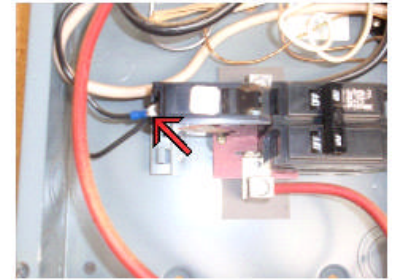
Double tapped breaker shows two wires incorrectly connected to one breaker. Recommend further evaluation by a licensed electrical contractor.

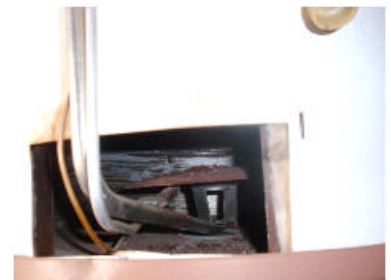
There is rust on the underside of the tank.

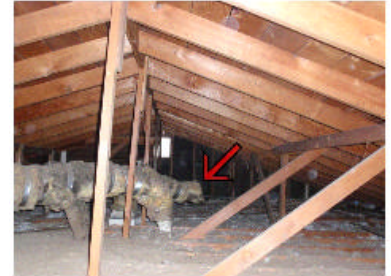
Attention Needed - The ducting system may not be terminated properly. All vents appeared to have sufficient air flow. Recommend further evaluation prior to removal of contingencies.

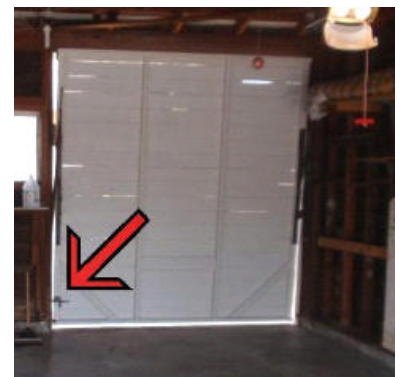
Operated manual wooded garage door that opens to the side patio. Operates OK. Latching needs repairs or replacement.

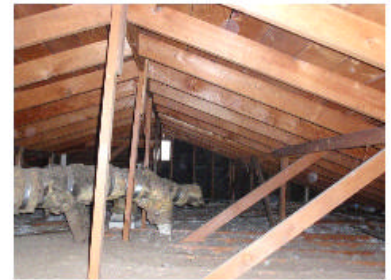
The insulation is in contact with the roof sheathing. This condition needs to be changed. There needs to be at least a 1 1/2" air gap between the insulation and the sheathing. This contact will lead to condensation in the attic. It also limits airflow which ventilates the attic.
