Inspection Perfection

Re Inspection at: **123 Main St**
San Diego , CA 92115

Confidential Inspection Report

123 Main St
San Diego, CA 92115

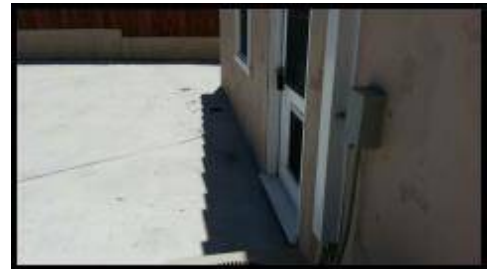
3.6 LOCATION/TYPE/CONDITION

Location - Back, Type - Concrete, Conditions - Grading - Not properly sloped. May cause water to drain towards building. **Recommend** to evaluate further prior to removal of contingencies.

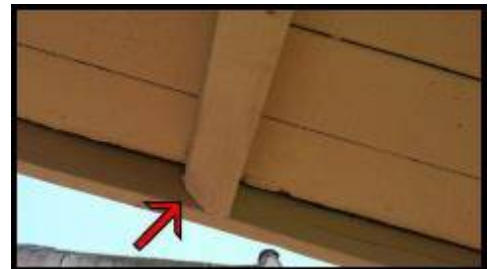
Conditions - **Attention**. Noted repaired item. **Recommend** further evaluation prior to removal of contingencies.

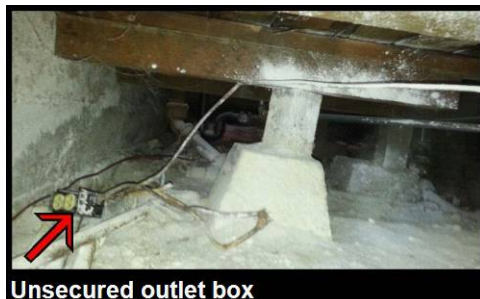
Wiring needs to be secured every 4 1/2 feet. This poses a safety hazard when servicing crawlspace. **Recommend** correction. Noted areas of disconnected wiring. **Recommend** removal.

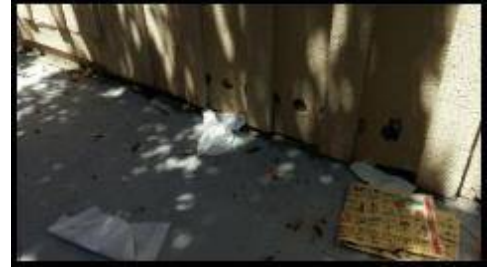
5.4 Siding Comment:

Attention - Plywood siding is in contact with ground. Should have separation. Water from ground will wick up and deteriorate siding. **Recommend** further evaluation by a licensed general contractor prior to removal of contingencies.

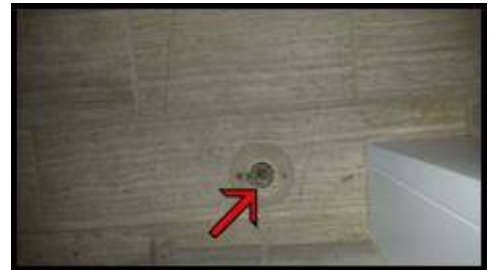
The fireplace has a gas starter. It was not lighted. **Action** - Valve is not operable. **Recommend** further evaluation by a licensed general contractor prior to removal of contingencies.

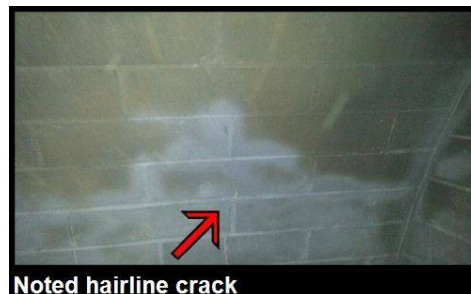
Attention - Noted hairline cracks. Appears to be serviceable.
Recommend to monitor for further deterioration, Glass Doors - There are no glass doors installed. These could help minimize heat loss from the room when fireplace is not in use. When the fireplace is in use, they will eliminate embers from flying into the room and reduce the volume of room air sucked up the chimney.

Noted hairline crack

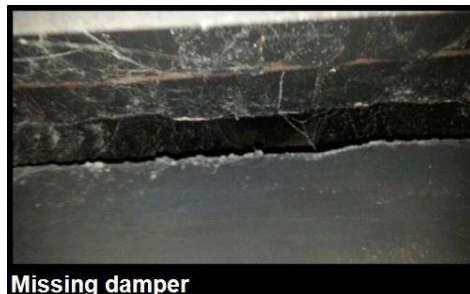
The damper is either missing or was never installed. Services of a licensed professional mason would be needed to estimate repairs. Either way, one needs to be installed to prevent the heated room air from going up the fireplace flue when the fireplace is not in use. There is no damper installed. Installation is expensive if not provided for in the original installation. Glass doors may be an acceptable alternative.

Missing damper

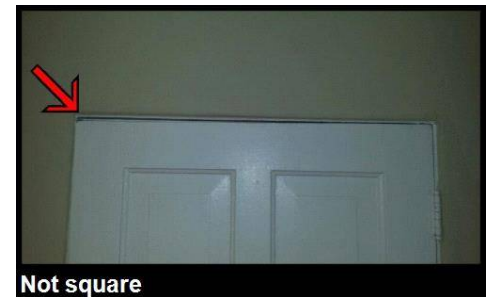
6.2 Front Entry Door:

Type - Solid wood, There is no deadbolt installed on the main entry door. The guest at the front door is visible by either a window in the door or next to it, or by a viewing lens. Weatherstrip is serviceable. **Attention Needed** - Noted door is not square with framing. Recommend correction. May also indicate building settlement.

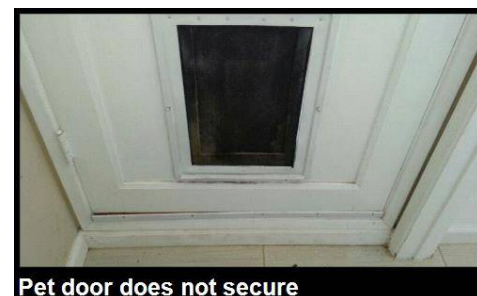
Action - Pet door is not secureable. **Recommend** further evaluation by a licensed general contractor prior to removal of contingencies.

Pet door does not secure

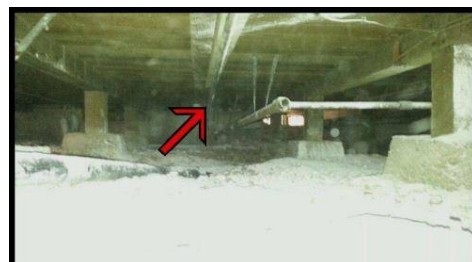
Recommend to evaluate further prior to release of contingencies.

Lacks support

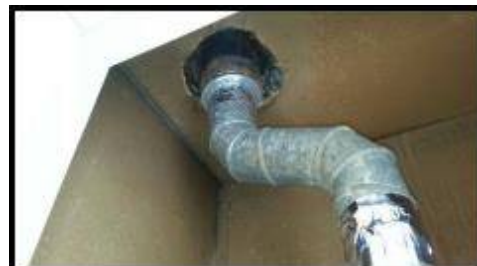
Type - Single wall metal, **CONDITION** - Unit was tested for proper drafting. **Action Necessary** - The vent system is in need of Immediate Action due to open connections, inadequate draft, or incorrect slope. Venting system is not properly drafting combustion gas. Danger of leaking combustion gas containing carbon monoxide. **Recommend** further evaluation by a licensed plumber.

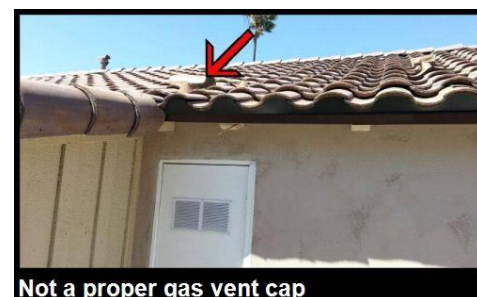
Action - This vent cap is not a gas vented cap. Recommend correction. Type -

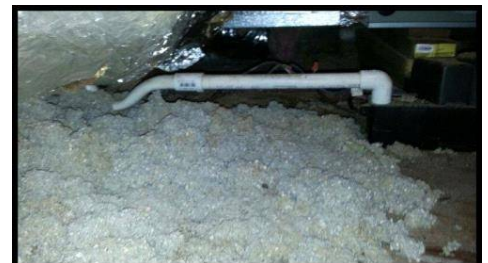
Secondary line is not installed. Secondary line is required to alert that the primary line is possibly clogged and could create water damage. **Recommend** installation by a licensed HVAC contractor.

Requires 2nd drain line

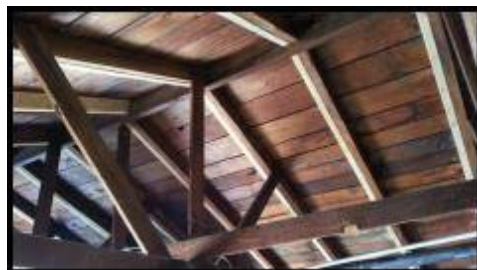
14.7 Garage Ceiling

Noted repairs.

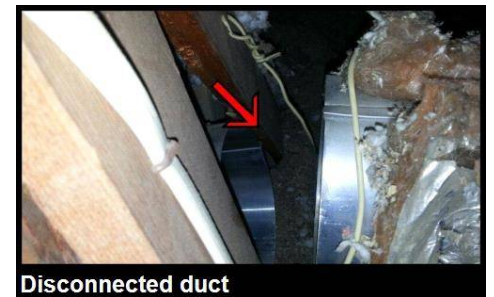
Location: attic, Type - Noted older rigid ducting system that may have several conditions including leaking averaging 30% of conditioned air loss. May also contain asbestos, fiberglass and lack sufficient insulation. **Recommend** to have ducting system evaluated prior to release of contingencies. Satisfactory - The ductwork appears to be properly installed and supported.

Disconnected duct

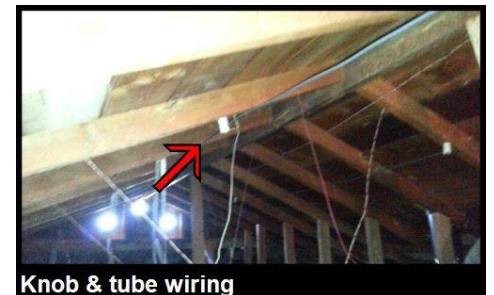
Action - The presence of Knob & Tube wiring prohibits installation due to potential of overheating See Electrical section.

Knob & tube wiring

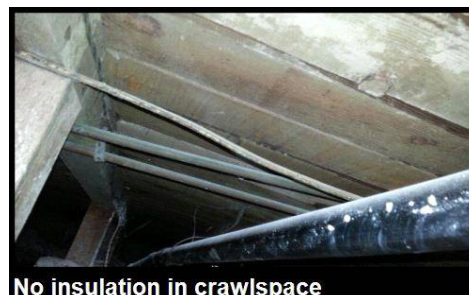
No insulation noted. Proper installation of insulation to increase the energy efficiency of the house is recommended.

No insulation in crawlspace

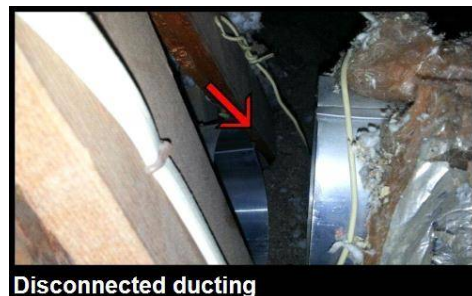
Connections - Noted disconnected ducting. **Recommend** further evaluation by a licensed HVAC contractor.
