Inspection Perfection

Re Inspection at: **123 Main St**
San Diego , CA 92115

Confidential Inspection Report

123 Main St
San Diego, CA 92115

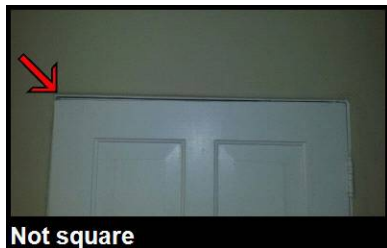
6.2 Front Entry Door:

Type - Solid wood, There is no deadbolt installed on the main entry door. The guest at the front door is visible by either a window in the door or next to it, or by a viewing lens. Weatherstrip is serviceable. **Attention Needed** - Noted door is not square with framing. Recommend correction. May also indicate building settlement.

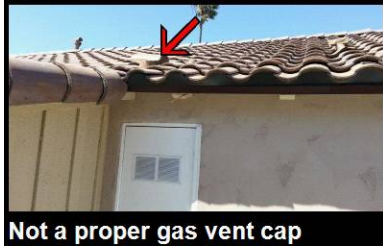
11.20 Flue/Exhaust Pipe Condition:

Action - This vent cap is not a gas vented cap. Recommend correction.

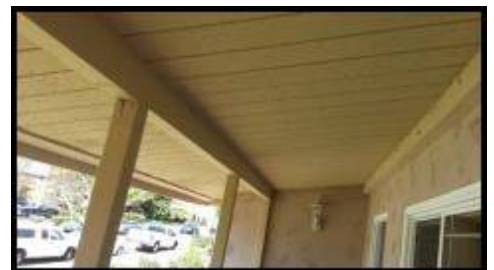
3.7 TYPE/CONDITIONS

Conditions - **Attention**. Noted repaired item. **Recommend** further evaluation prior to removal of contingencies.

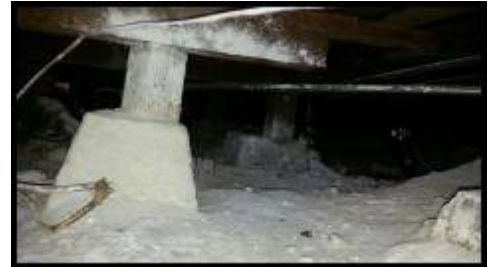
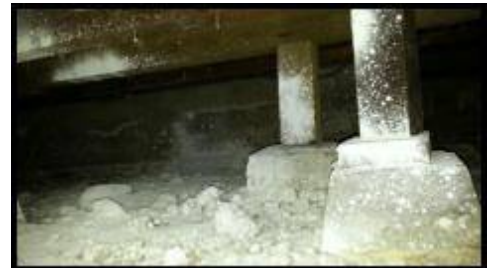
4.11 Posts:/Piers

Posts - Satisfactory - There is at least one post supporting an overhead beam in the crawl space. It appears to be adequately installed. Piers - Exposed concrete piers at least 8" in diameter are visible in the crawlspace. Conditions - Satisfactory - The piers as installed appear to be adequate. Confirmed sample piers are set in poured concrete. No engineering analysis was completed. Noted one or more locations where post/pier system added for additional support.

Noted one or more locations where post/pier system added for additional support. Posts -

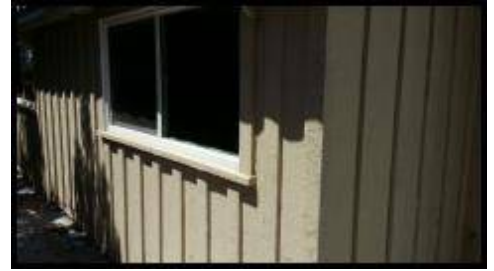
5.3 Siding Conditions:

Vertical Plywood.

Attention - Plywood siding is in contact with ground. Should have separation. Water from ground will wick up and deteriorate siding. **Recommend** further evaluation by a licensed general contractor prior to removal of contingencies.

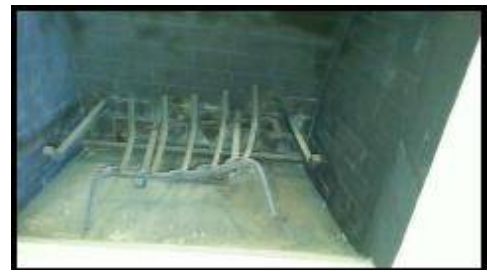
5.13 Firebox Condition:

Attention - Noted hairline cracks. Appears to be serviceable.
Recommend to monitor for further deterioration, Glass Doors - There are no glass doors installed. These could help minimize heat loss from the room when fireplace is not in use. When the fireplace is in use, they will eliminate embers from flying into the room and reduce the volume of room air sucked up the chimney.

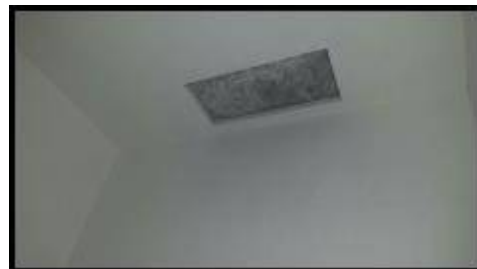
Walls - Satisfactory - The walls in this room appear to be satisfactory. **Ceilings - Attention Needed** - There is a condition in the ceiling that needs to have attention. Portion of ceiling may not meet minimum ceiling height. **Recommend** further evaluation by a licensed general contractor prior to removal of contingencies.

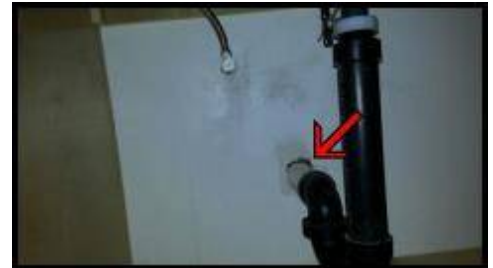
9.34 Basin and Drain Fixture:

Satisfactory - The basin and drainage fixture appears to be satisfactory. No leaks were noted during evaluation. **Attention** - The basin or drainage fixture needs attention. Supply and drain lines should be sealed thru walls to minimize vermin infestation. **Recommend** correction. Trap - Properly installed.

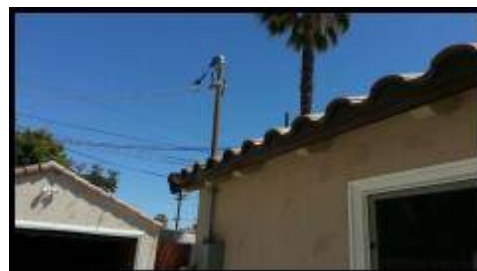
10.1 Service Voltage:

The incoming electrical service to this structure is 120/240 volts. Service Entrance/Meter - Overhead/Satisfactory - The masthead, supports, meter housing, and cable entrance to the structure appear to be correctly installed.

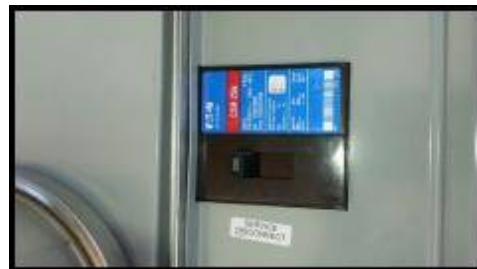
10.3 Main Panel

Brand - Eaton Capacity - 200 amp - The ampacity of the main power panel appears to be more than adequate for the structure as presently used with room for expansion.

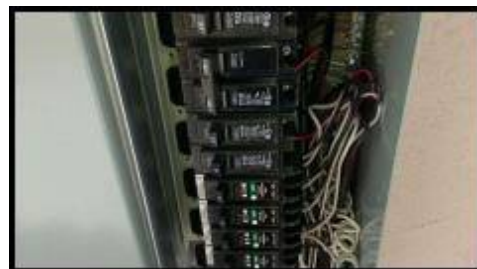
10.10 Feeder and Circuit Wiring Type:

Copper - The structure is wired using plastic insulated copper single conductor cables commonly referred to as Romex.

Noted Knob & Tube wiring in the attic. Cannot determine if in use. As this is beyond its estimated age and has no grounding wiring, **Recommend** further evaluation by a licensed electrical contractor.

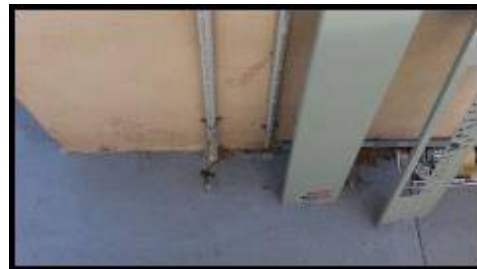
10.13 Comments:

Action - Noted grounding wires in panel. Most of the living areas had two wire outlets without grounding protection. **Recommend** further evaluation by a licensed electrical contractor prior to removal of contingencies.

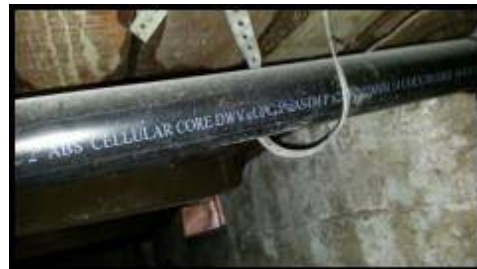
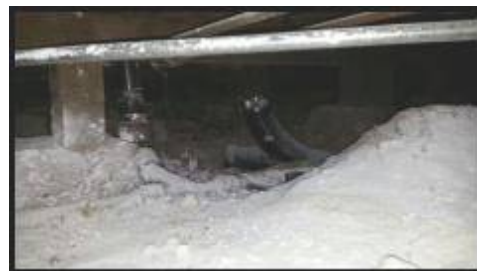
11.8 Waste Line

Limited - Determination of waste line type and inspection is limited to accessible areas in unconditioned area attics, crawlspaces and under sinks. **Recommend** to have waste line inspected with a video camera prior to removal of contingencies.

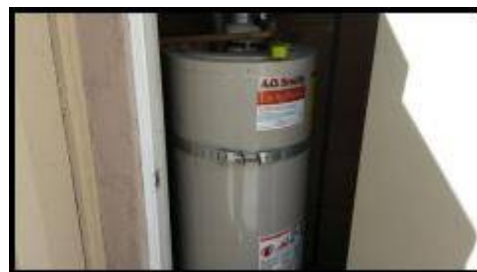
11.14 Model & Serial Numbers:

Brand - AO Smith, Energy Saver, Tank capacity is 40 gallons. Manufactured year: unknown. **Attention**

- The water heater appears to be at or near the end of its economic life. Although it is functional today, you should plan for its replacement.

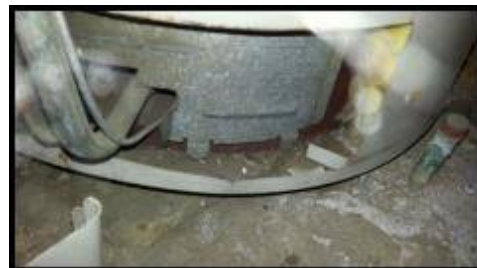
11.20 Flue/Exhaust Pipe Condition:

Type - Single wall metal, **CONDITION** - Unit was tested for proper drafting. **Action Necessary** - The vent system is in need of Immediate Action due to open connections, inadequate draft, or incorrect slope. Venting system is not properly drafting combustion gas. Danger of leaking combustion gas containing carbon monoxide. **Recommend** further evaluation by a licensed plumber.

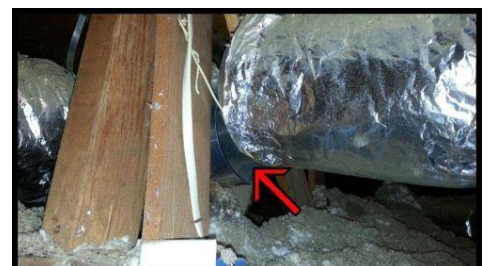
disconnected ducting

Temperature at supply registers. 46-52 Temperature of ambient air - 72. **Temperature differential** - Satisfactory. The desired temperature drop across the evaporator is 14 - 22 degrees F. Register located in the **Bedroom #2 & kitchen** had poor/no airflow and did not providing any cooling or heating conditioned air. Ducting system may be damaged or disconnected. **Recommend** further evaluation by a licensed HVAC contractor prior to removal of contingencies. Noted disconnected duct in attic.

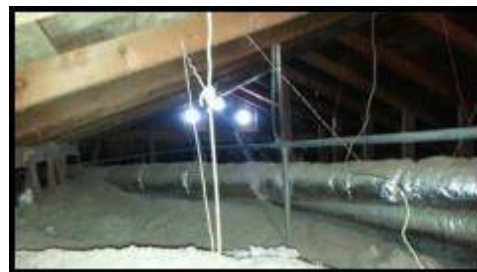
Ventilation systems provide airflow to ventilate heat buildup, moisture and required to preserve roof system.. Vents should be installed lower and higher to be effective. Lower vents should not be blocked by insulation to allow airflow. Current industry standards recommend as a minimum, one square foot of free vent area for each 150 square feet of attic floor. With a vapor barrier installed, one square foot of free vent area per 300 square feet of attic space are needed. There are gable end vents installed, Screens, Appears properly installed.

Attention Needed - There appear to be vents installed; however, the existing vents need some attention in order to perform correctly.

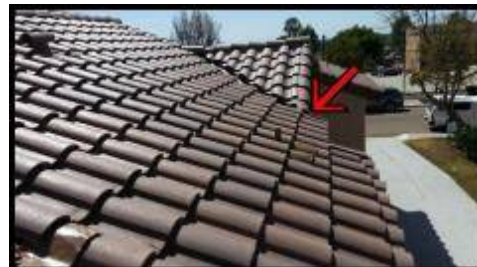
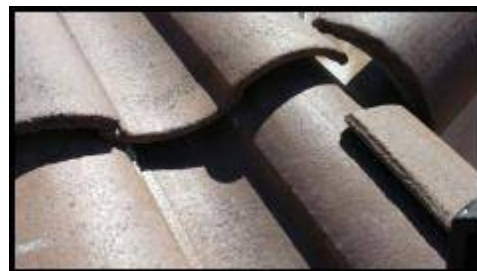
15.20 Valleys:

Valley roofing installations are important. All valley installations require an additional waterproof membrane that extends about 12 " beyond the valley. This is not visible or verifiable in the inspection. Many times the manufacturer has specific instructions recommended for this type of roofing. It is not possible to identify manufacturer and their type of material. Type of valley installation - The valleys on the roof are open with metal valleys. **Action** - Valleys should terminate to the edge. Water may be directed under a portion of tiles. **Recommend** further evaluation by a licensed roofing contractor prior to removal of contingencies.

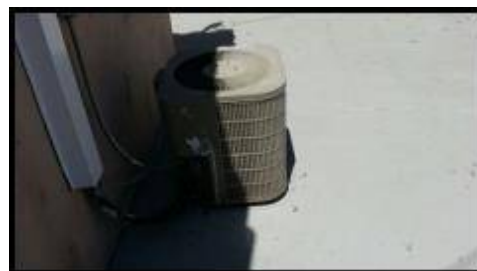
18.6 Assessment

Unit appears to be old that may be beyond its estimated life. This unit predates mandatory higher energy efficient standards. The SEER rating cannot be determined at time of inspection. **Recommend** further evaluation with a comprehensive energy assessment. There are numerous incentives including rebates & financing available to reduce costs to improve energy efficiency. SEER rating is estimated to be 10 based on label or age of unit.

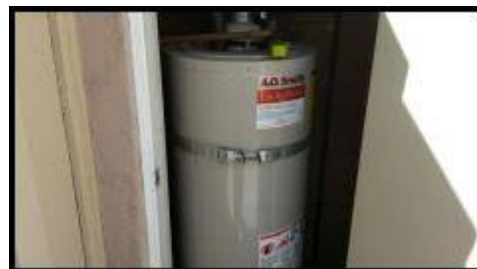
19.4 Assessment

Tank - Water heaters have an estimated life of 10-15 years. Sediment buildup can impair heating effectiveness. Energy factor range .55-.62

Unit is near/at end/beyond estimate life. **Recommend** to replace unit with a higher energy efficient model with EnergyStar rating, condensing or tankless.
